*FY-17 Installation Technology Transfer Program*

## **Performance Testing of a Novel Dry-Fog Mold Remediation and Prevention Process**

Shane D. Hirschi and Dale L. Herron

**DRAFT** - October 2017

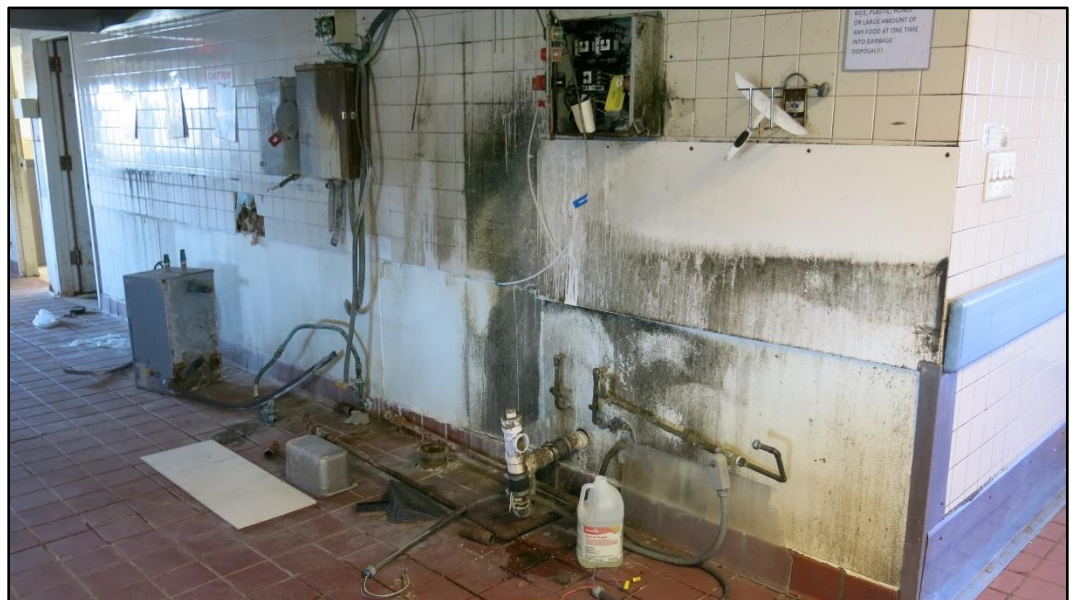
Figure 4. Kitchen area inside Building 2261

**Building 2261** – is a vacant dining facility having an interior of 4000 ft<sup>2</sup> of which approximately 3700 ft<sup>2</sup> were treated. Figure 3 provides a view of the exterior of the facility. Figures 4 and 5 provide visual representation of the existing conditions inside the facility. Visual mold was present on most all surfaces to varying degrees.

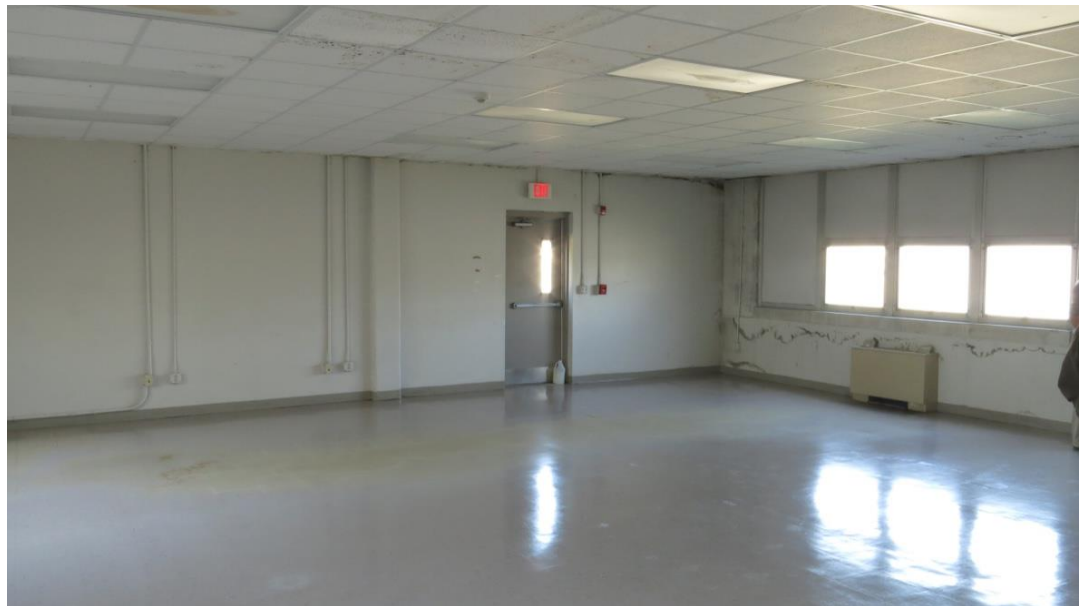
Figure 7. Classroom area inside Building 6733

**Building 6733** – is a vacant hammerhead style barracks facility having an interior of 38,000 ft<sup>2</sup> of which approximately 2800 ft<sup>2</sup> were treated. Figure 6 provides a view of the exterior of the facility. Only the administrative area of the first floor (i.e. classroom, offices and restrooms) were included in this demonstration. Figures 7 and 8 show the amounts of visible mold on the wall surfaces.

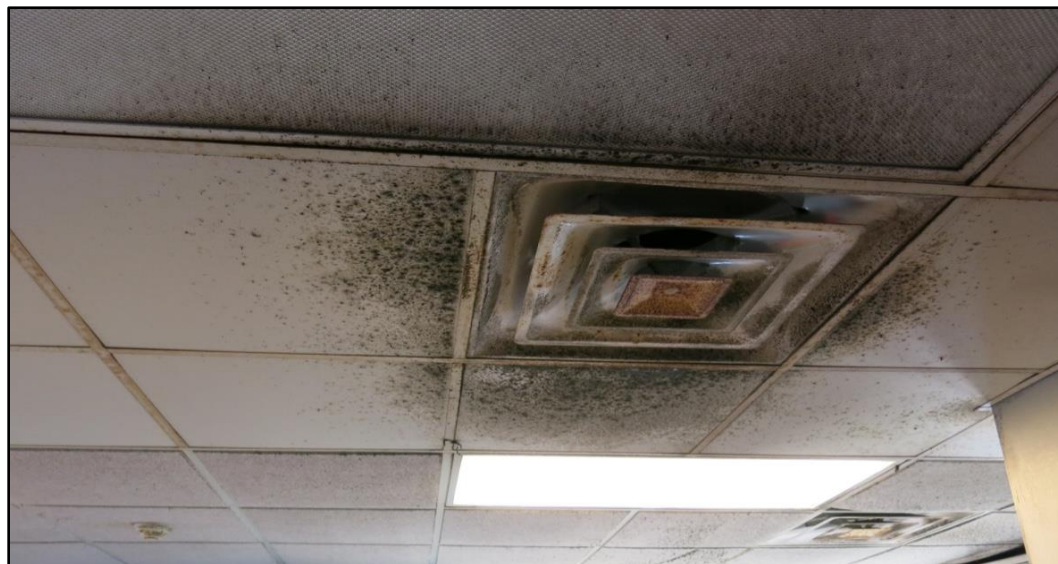
Note the “treatment” does not “remove” the black appearance of mold (Figure 19). However, mold spores can be eliminated and still appear as though they are there (i.e. the surface may still look as it did prior to treatment). It is essential that air and surface sampling are performed (before and after treatment) to provide quantitative measurements of the treatment’s removal effectiveness.

Figure 19. Mold growing near duct vents in Building 2261

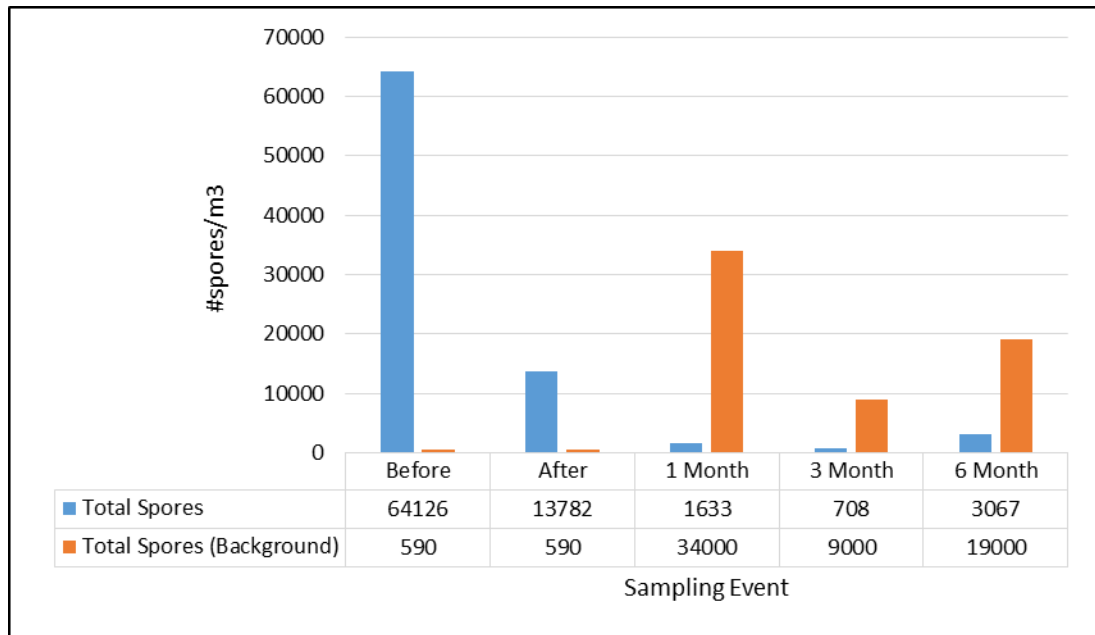
As shown in Figure 22, the total spore count weighted across all air sampling locations associated with Building 2261 decreased from 64,126 spores/m<sup>3</sup> prior to treatment, to 3,067 spores/m<sup>3</sup> at six months after treatment. Over this same time period, the outdoor/background total spore count increased from 590 spores/m<sup>3</sup> prior to treatment, up to 19,000 spores/m<sup>3</sup> at six months after treatment. Simply put, while the outdoor/background total spore count increased 3,120%, the indoor (i.e. treated space) total spore count decreased 95.21%.

Figure 22. Bldg 2261 - Total Spores vs Total Spores (background)

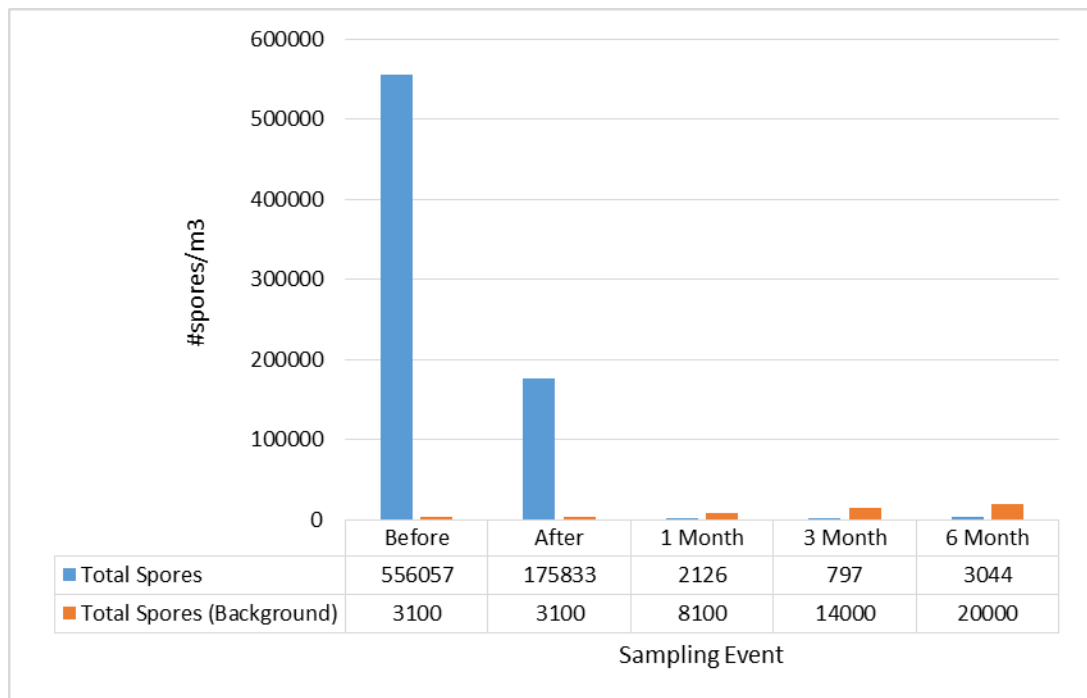
In Figure 25, the total spore count weighted across all air sampling locations associated with Building 6733 decreased from 556,057 spores/m<sup>3</sup> prior to treatment, to 3,044 spores/m<sup>3</sup> at six months after treatment. Over this same time period, the outdoor/background total spore count increased from 3,100 spores/m<sup>3</sup> to 20,000 spores/m<sup>3</sup> at six months after treatment. As the outdoor total spore count increased 545.2 %, the indoor (i.e. treated space) total spore count decreased by 99.45%

Figure 25. Bldg 6733 - Total Spores vs Total Spores (background)

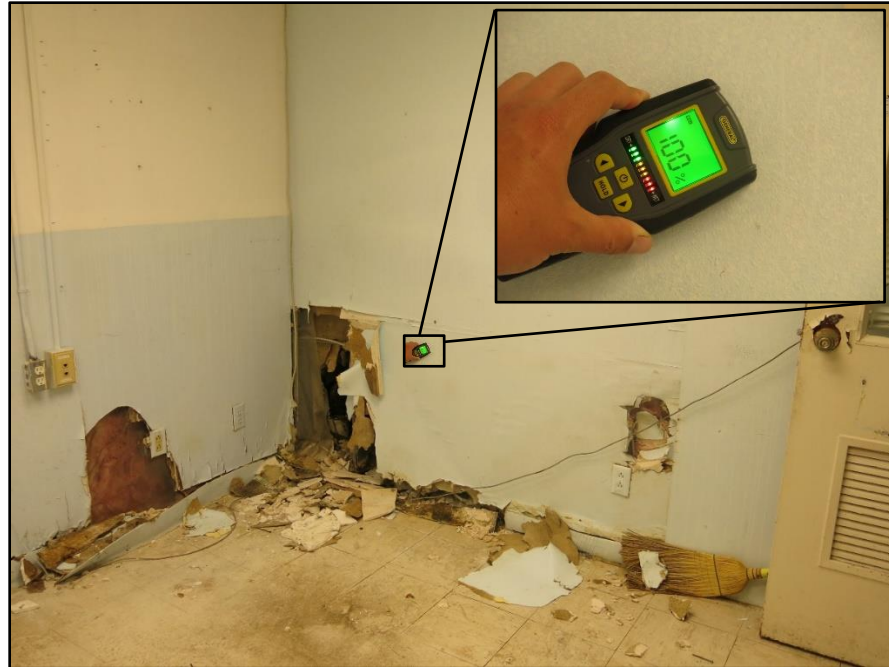
Samples #3 and #4 show an increase in hyphal fragments at the 6 month sampling event (highlighted in yellow). Even though the levels increased (from zero for the previous sampling events), they are still well below the levels prior to treatment. However, they are above the background level of zero. Ideally a future sampling round could potentially determine if this is an increasing trend, or an increase due to activity within the room where sample #4 was taken, and adjacent to the area represented by sample #3.

While performing the 3 month sampling event, team members encountered demolition activities in the room represented by sample #4. Figure 27 shows the debris and the meter reading showing one-hundred percent moisture content on the wall surface. The wall was damp to the touch and clearly saturated with water. The adjacent room, represented by sample #3 had recently began to leak from the ceiling, as shown encircled in Figure 28. These changes to the interior environmental/structural conditions are believed to have played a role in the increased total spore count. However, it should be noted that the background total spore count continued to increase beginning with the 1 month sampling event through the 6 month sampling event, where background was between four and seven times greater than the indoor sample results.

Figure 27. Wall surface moisture content of 100% near sample location #4.

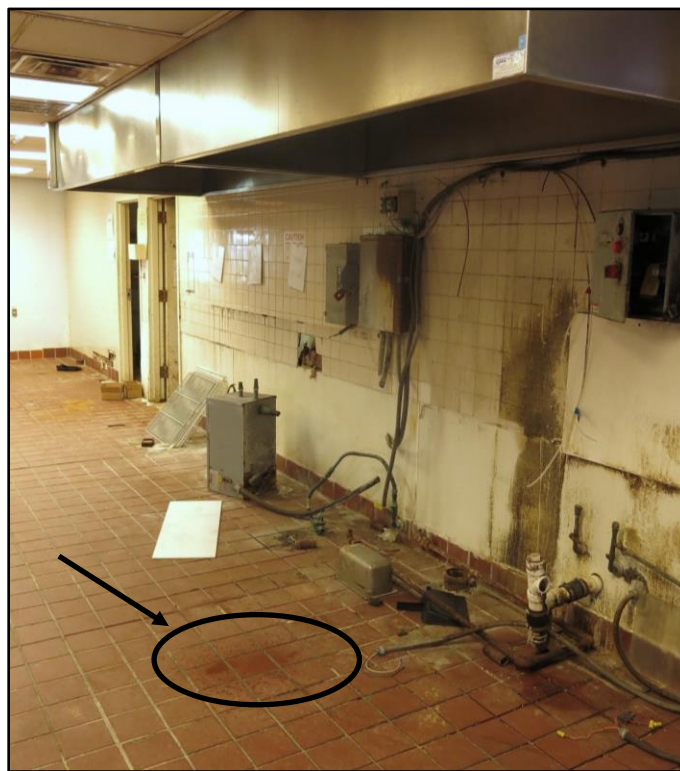
Figure 28. Leakage from ceiling piping or roofing
